IMPACT OF LDEF PHOTOVOLTAIC EXPERIMENT FINDINGS UPON SPACECRAFT
SOLAR ARRAY DESIGN AND DEVELOPMENT REQUIREMENTSLeighton E. YoungNASA Marshall Space Flight Center
Marshall Space Flight Center, AL 35812
Phone: 205/544-0707, Fax: 205/544-5847

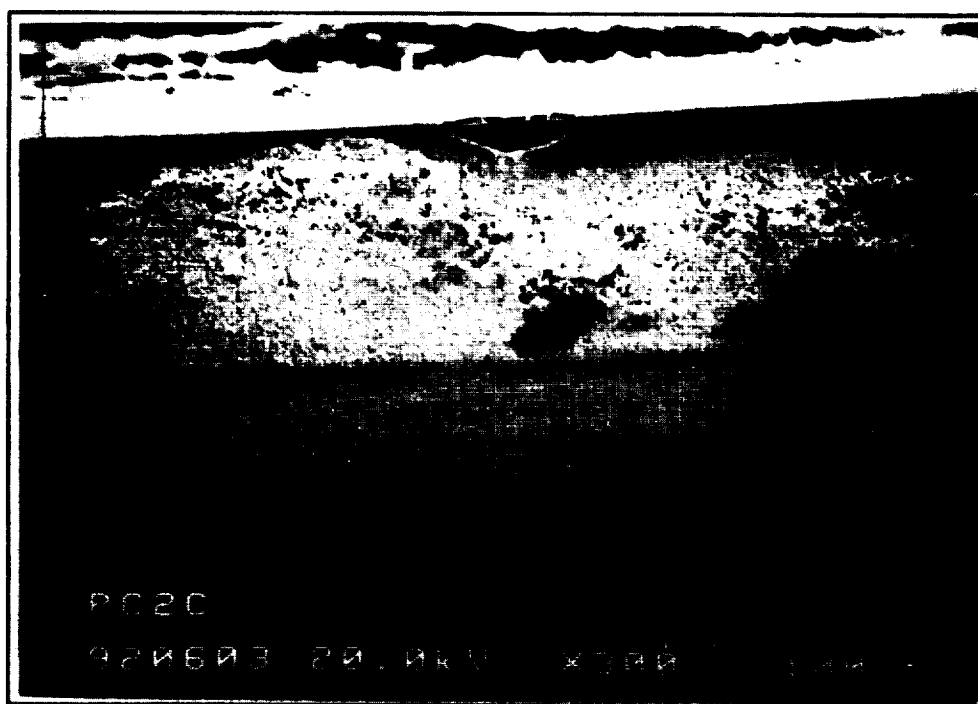
Figure 6. Scanning electron microscope image of SAMPLE solar cell wraparound contact erosion from AO.

Exposed silver metalization showed differing effects of AO interactions depending upon application. SAMPLE cell "Cell 6," which was flown without a coverslide, leaving its silver gridlines exposed to the AO flux, exhibited oxidation of grid lines but no noticeable erosion. Removal of the oxide layer revealed that it composed only about 10 percent of the gridline thickness. Some cells on Module 5 exhibited considerable erosion (Fig. 6) of the silver metalization that wraps the front side electrical connections of the solar cell to the cell rear surface. This erosion manifests itself in severe electrical performance degradation, to be discussed later in this paper. APEX cells B32 to B35, which had polymeric cover materials, showed differing oxidation effects. Cells B32 and B33, which employed a 1-mil silicone (Dow-Corning 93-500) protective cover had gridlines that were still bright even in areas where the cover layer had been peeled from the cell. Cells B34 and B35, which had cast fluorinated ethylene propylene (FEP-LMSC Spraylon) covers showed apparent oxidation of the gridlines with no observable cover peeling. Considerable cracking of the Spraylon covers was observed under 32× magnification. Differences in the level and type of AO interactions with silver in applications which are similar must be attributed to synergistic effects.
